WHITMAN MIDDLE SCHOOL

# Building Assessment

## Executive Summary

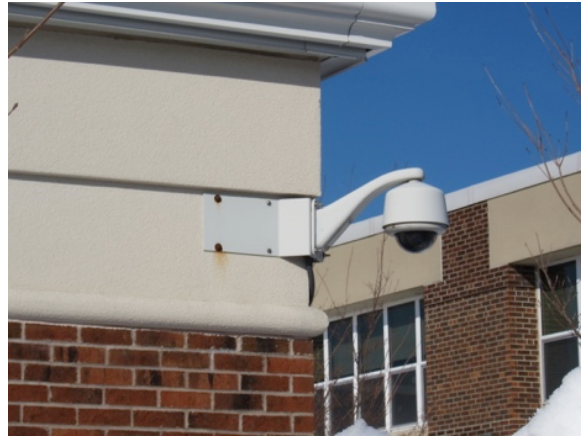
The overall security around campus is good. There are security cameras covering the entire perimeter of the school. Lighting at night is sufficient to deter activity in remote corners of the facility. Inside the school, there are cameras to monitor activity in common areas. The security cameras are monitored inside the administrative offices. The camera's DVR is inside the server room, which has direct fiber connection to the main IT hub for the school district.

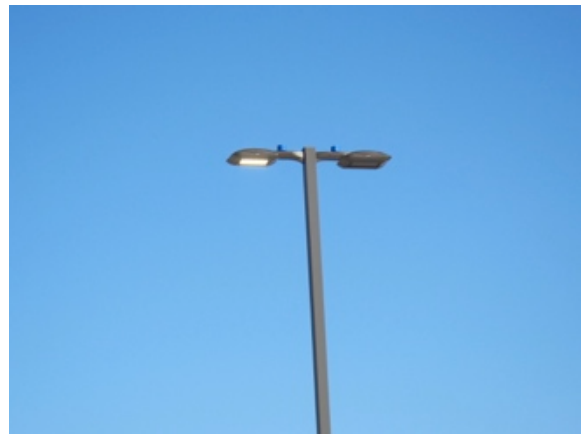
The school grounds have LED light posts covering the parking areas and metal halide lights mounted to the exterior walls of the structure. All of the lights appear to be in good working order. There are two light poles in the parking lot that require repair. The two poles appear to have been struck by plowing equipment. The wood poles do not seem to have been broken, however they are leaning and need to be placed upright again. Additionally, there is an issue with the photocell sensor for at least one of the light poles; one of the LED poles is remaining lit during daylight hours. This should be a minor repair, as all other lights seem to be responding properly to the control mechanisms.

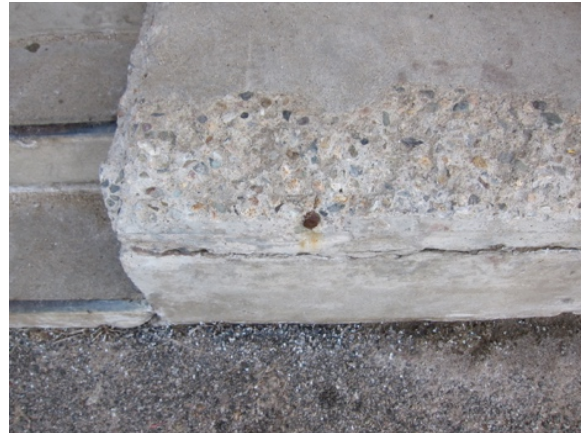
The original exterior surfaces had cracks, spalling, and stains. The mortar joints around the original construction showed signs of moisture penetration and chunks of the mortar were missing. Moisture has been penetrating the upper level around the cafeteria and damaging interior surfaces. The expansion joint fillings were dried out and separating from the masonry. These joints are no longer weather proof. The concrete foundation surfaces were also spalling with some small cracks and there were larger spots of missing concrete in some places. The penetration points for ventilation had larger gaps forming around the edges and flashing is in need of repair or replacement.

There was some damage found to the gutters and roof flashing around the newer construction near the nurse's office. A section of the gutter has broken and was hanging down from the side of the building. Along that same edge, there was a section of the flashing that was deformed and bent upward. This damage appeared to be the result of some impact. The source was not obvious.

Repointing of masonry and replacement of expansion joints is needed. After the repointing is complete, the surface should be sealed with an appropriate product. There should be repairs made to the concrete foundation, particularly around high use places such as the loading docks behind the kitchen area. Finally, some attention should be given to the vegetation at the southeast corner of the building.

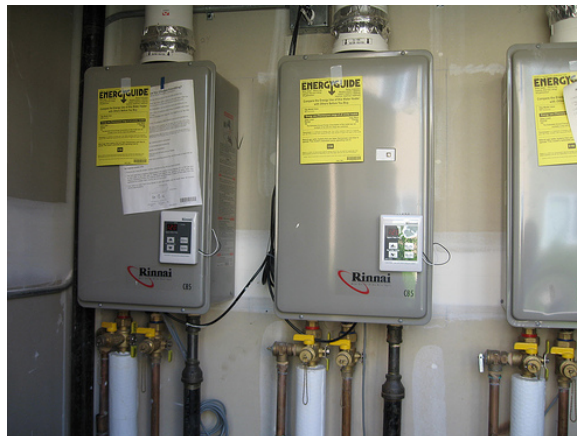
The water heater is a 75-gallon gas-burning model. The system has an 80 percent thermal efficiency. This system was manufactured in 2008 and put in place as a temporary fix when a larger system began to fail. A permanent solution should be put in place as soon as possible.

The amount of hot water required at any given time is achievable with a tank-less water heating system. The flow rate could be achieved by placing two to three units in succession. From an efficiency perspective, selecting a tank-less gas water heating system would be a good long-term solution. If not incentivized, this type of system would not have a good ROI; there is an \$800 incentive available to Massachusetts' gas utility customers, which may offset a considerable portion of the cost. If utilized, the incentive would make the upgrade well worth the investment. At this time the incentive is good for systems put into use during the 2015 calendar year. If this option should be pursued, the system selected must satisfy a >.94 energy factor rating on the electronic control components.

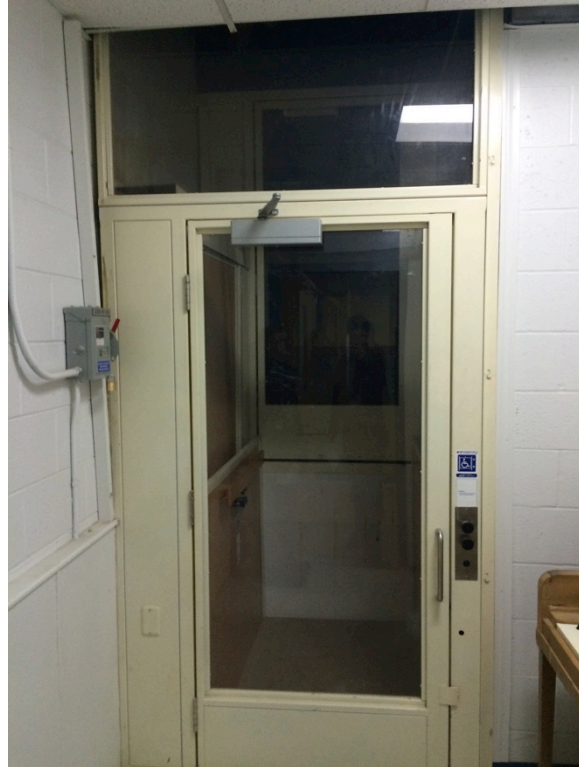
There are two lifts in the school. The first is a hydraulic elevator that provides service from the first floor to the second. It was original to the building's construction in 1972. The maintenance manuals and service records show routine preventative maintenance (PM); the elevator appears to be in excellent working condition. Upon inspection of the elevator room, it seemed to be extremely clean and well maintained. If the upkeep is continued, this system should continue to provide reliable service.

The second lift is designed for wheelchair access to the stage area. The lift was brought on line during the 2000 renovation. There is a service contract in place to ensure upkeep of the lift. Both lifts appear to operate correctly and should continue to provide the needed service for the building.

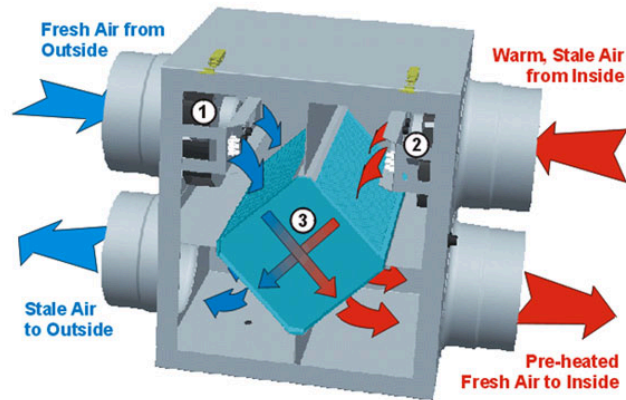
In the exercise room, the same style air handler is hung from the ceiling. This unit is also in good shape, and only requires routine maintenance. If not already in place, a regularly scheduled preventive maintenance plan should be put into effect. The exercise room's air handler could also benefit from a digital control system and variable frequency drive.

One recommendation that may help resolve the moisture build up in the gym is to install a Heat Recovery Ventilator (HRV). A HRV would help expel the moisture that is accumulating in the upper level of the gym. This system would also improve the efficiency of the heating. The system recovers heat from the air that is being exhausted. The heat warms any air coming into the system before the air passes through the heating coils. The current system relies on natural air pressure to exhaust heat and moisture from the space. An active air exhaust system would improve the conditions that are contributing to the existence of mold.

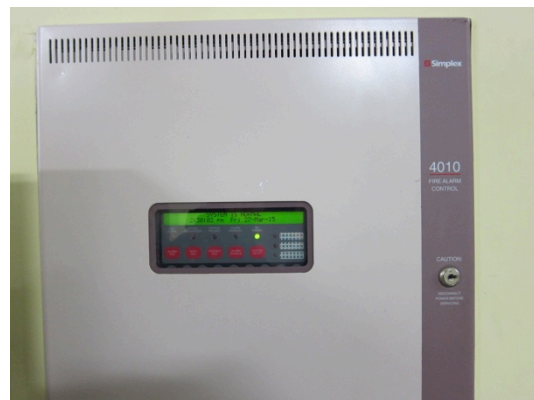
*Simplex 4010 Panel*

The fire alarm system seems to be excellent quality. The annunciator panel is a Simplex 4010, which works great with mid sized facilities. It has many features such as being able to detect faulty or dirty detectors, which allows for a proactive maintenance schedule to be followed. The panel is located next to the school's PA system and adjacent to the front entrance. The system is easily accessible and allows the fire department to quickly locate the problem area.
